Building 106: Duplex Officer's Quarters

Year Built:	1890
Current Use:	Vacant
Historical Use:	Residential (Duplex Officer's Quarters)
Square Feet:	4,672(+2,336 SF basement)
Condition:	Poor ¹
Rehab Cost Estimate:	\$934,400 ² ; \$650,000–\$810,000 ³
Estimated Rental Rate:	To be determined

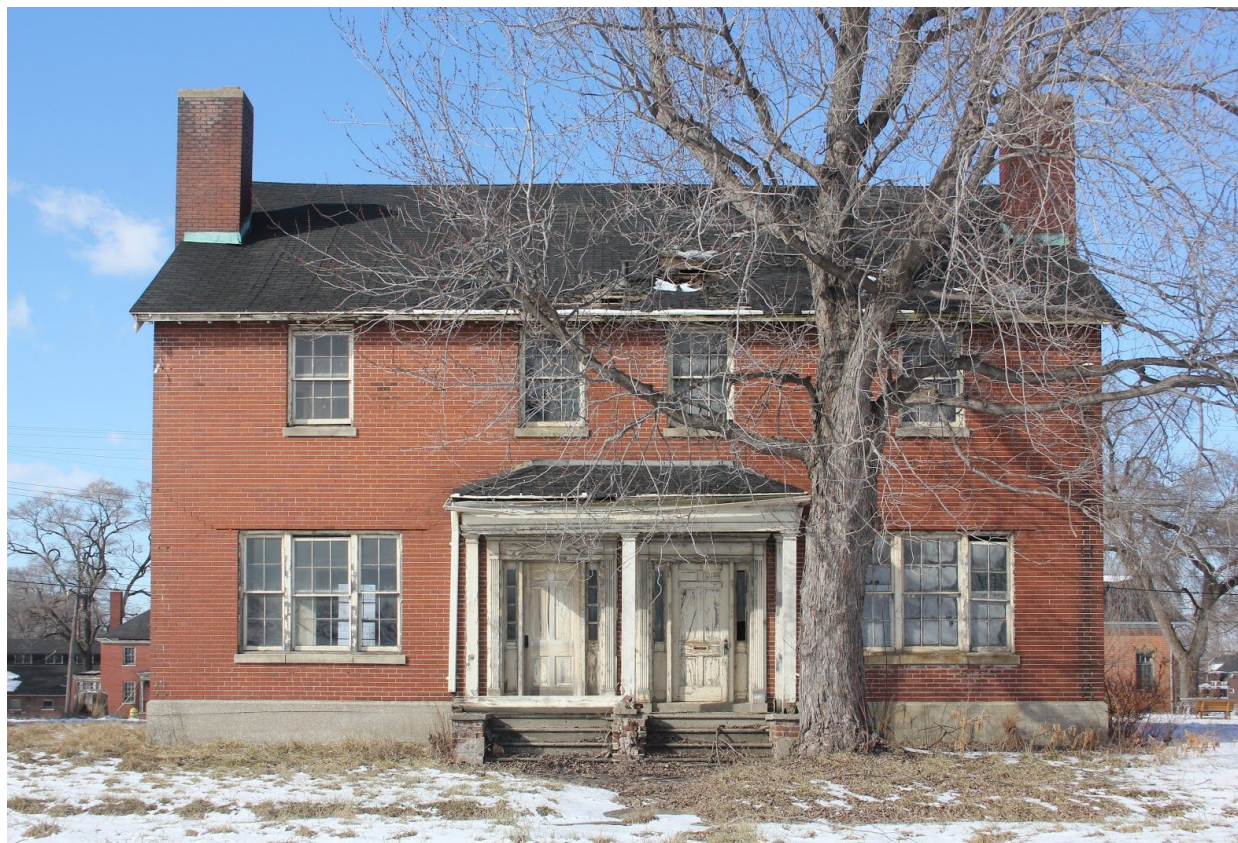
General Condition:	This building is in poor condition, according to a 2015 report. A condition assessment conducted in 2008 identifies horizontal foundation cracking (foundation in otherwise good condition) rusted lintels, shifted brick veneer, some eroded mortar due to pressure washing, (most mortar remains in good condition), deteriorated chimney mortar, masonry deterioration at rear porch, missing mortar at vertical sill joints, rotted and damaged fascia, missing gutters and leaders, deteriorated roof valleys, missing chimney cricket, a bowed roof ridge, front porch roofs in poor condition, rear porch roofs in fair condition, front porches in fair condition but missing railings. The building has suffered additional deterioration since 2008.
