## Building 213: Noncommissioned Officer's Quarters

<b>Year Built:</b>	1905
<b>Current Use:</b>	Vacant
<b>Historic Use:</b>	Residential
<b>Square Feet:</b>	2,290 (+ basement)
<b>Condition:</b>	Threatened <sup>1</sup>
<b>Rehab Cost Estimate:</b>	\$876,000 <sup>2</sup> ; \$690,000–\$860,000 <sup>3</sup>
<b>Estimated Rental Rate:</b>	To be determined

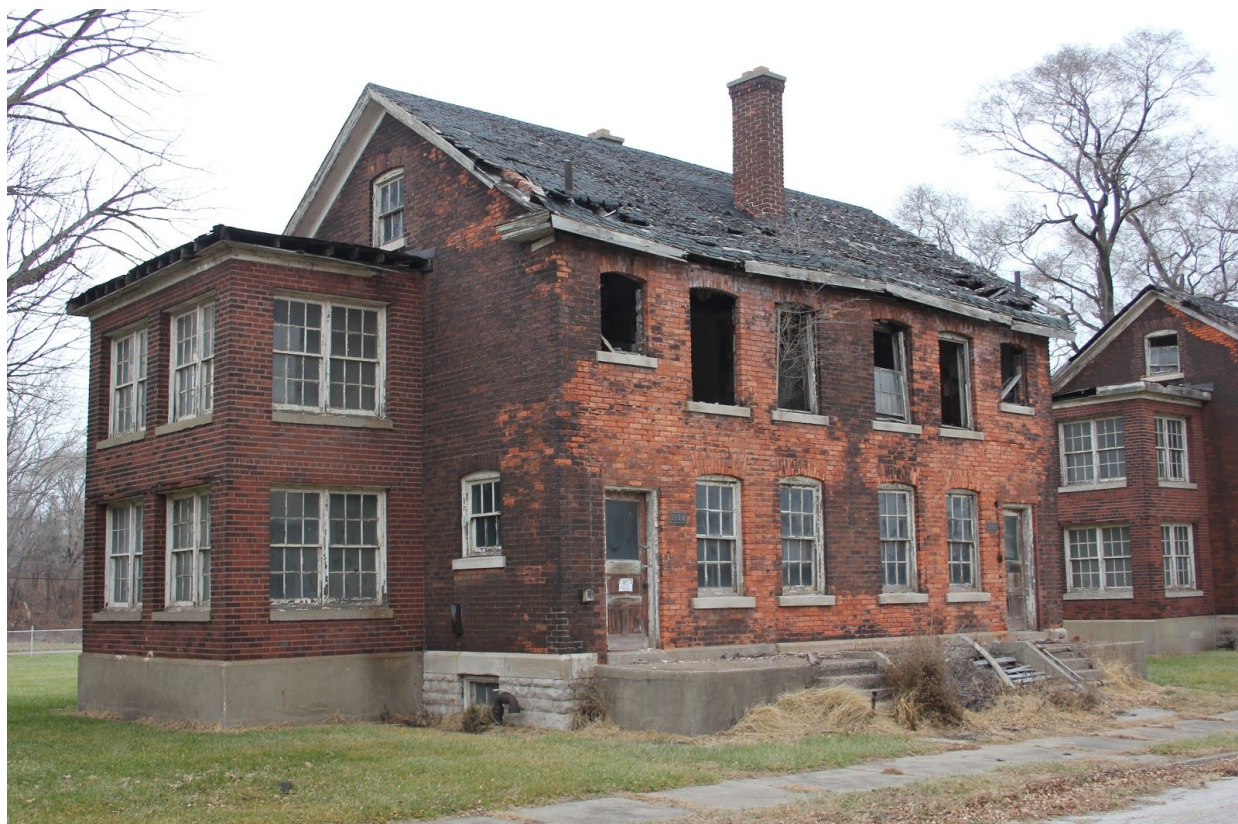
<b>General Condition:</b>	This building is in threatened condition, according to a 2015 report. A condition assessment conducted in 2008 identifies foundations in good condition, rusted lintels, mortar deterioration (especially severe at the south wall), one deteriorated chimney, one collapsed chimney, major water damage to masonry under south eaves, rotted eaves, missing gutters and leaders, paint in poor condition, rotted rafters and roof sheathing, metal porch roof in poor condition, front porch roofs with damaged structure, rear porch roofs missing. The building has suffered additional deterioration since 2008.
<b>Utilities:</b>	None
<b>Character-defining Features:</b>	<p>Exterior:</p> <ul style="list-style-type: none"> <li>• Concrete foundations</li> <li>• Red brick veneer walls</li> <li>• Enclosed front entrance porches with parapets</li> </ul>
