Building 311: Enlisted Men's Barracks

Year Built:	1894
Current Use:	Vacant
Historical Use:	Residential
Square Feet:	21,684 (+10,842 SF basement)
Condition:	Critical ¹
Rehab Cost Estimate:	\$6,972,000 ² ; \$5,240,000–\$6,550,000 ³
Estimated Rental Rate:	To be determined

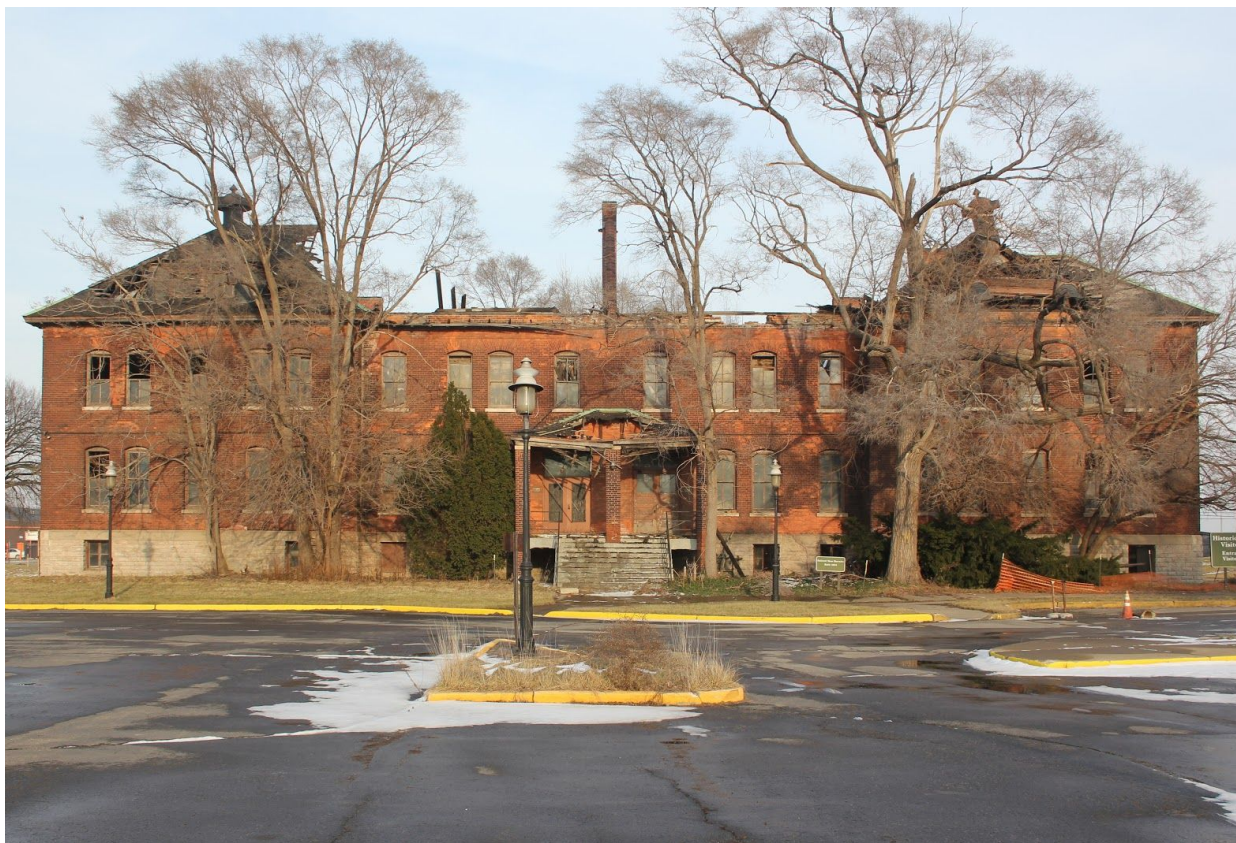
General Condition:	This building is in critical condition, according to a 2015 report, and appears to be near the point of structural collapse. A detailed conditions assessment was never conducted.
Utilities:	None
Character-defining Features:	<p>Exterior:</p> <ul style="list-style-type: none"> • Coursed ashlar limestone foundation • Red brick with tinted mortar • Regular fenestration pattern • Jack-arched window openings with limestone sills • Wood two-over-two windows • Projecting hip-roof front porch with brick supports • Hip roof <p>Due to building condition, the interior was not evaluated for character-defining features.</p>
