Building 102: Duplex Officer's Quarters

Year Built:	1898
Current Use:	Vacant
Historical Use:	Residential (Duplex Officer's Quarters)
Square Feet:	7,624 (+2,548 SF basement)
Condition:	Poor ¹
Rehab Cost Estimate:	\$1,524,800 ² ; \$1,260,000–\$1,580,000 ³
Estimated Rental Rate:	To be determined

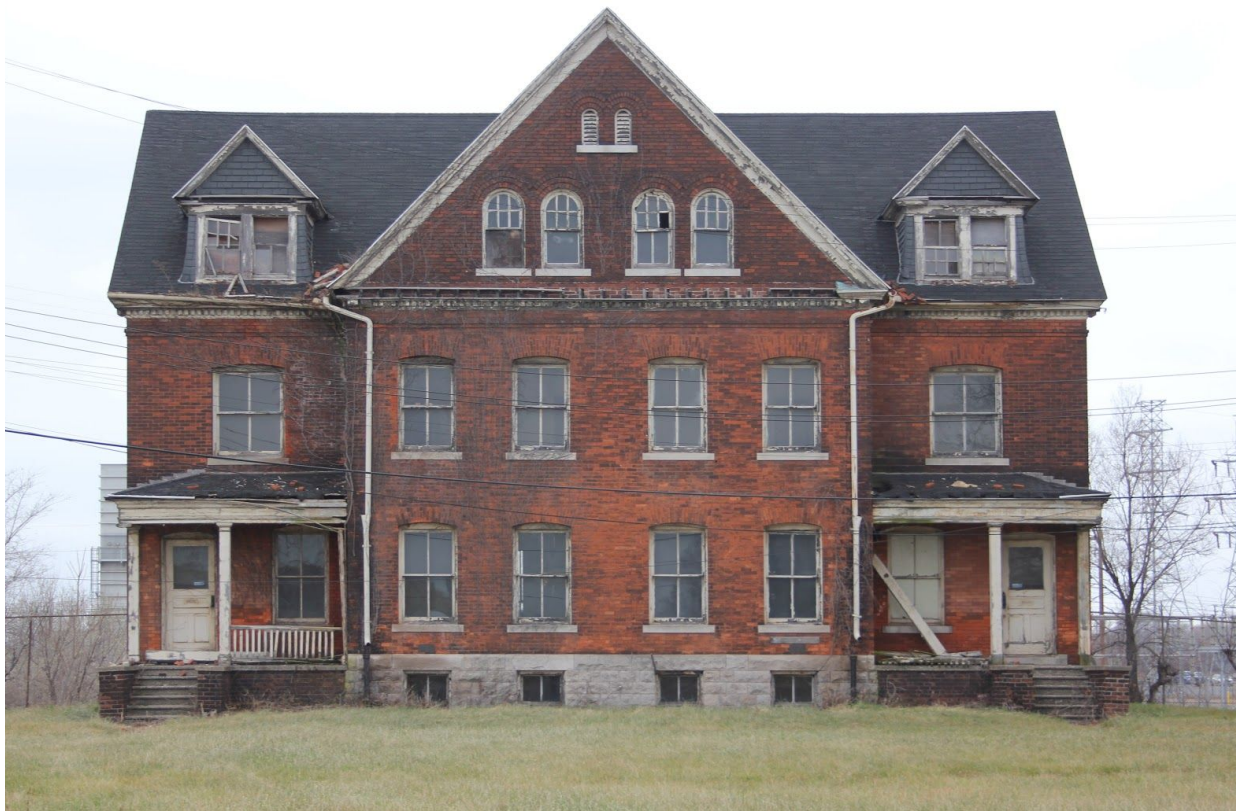
Building Typology:	“Type 4”, with 103 and 104 ⁴
Building Evolution:	The building exterior is largely unaltered from its original appearance, although brick masonry trash enclosures were added at some time during the building’s history. The interior was extensively remodeled by the Works Progress Administration during the years 1937–1939; interior woodwork and architectural details, tile work, and restroom fixtures date from this period.
Interior Description:	This duplex residential structure is two-and-one-half stories with a full basement. Each unit’s first floor consists of an entrance vestibule, lavatory, front hall, living room, dining room, pantry, kitchen, and rear stairway and entrance. The front stair to the second floor is open to the front hall. The second floor contains a stair hall with extension, four bedrooms, closets, a two piece lavatory, and a full three-piece bathroom. The rear stair leads from the second floor to an attic that is separated into several finished rooms. The two main floor levels have fully plastered walls and ceilings. All original plaster and woodwork were removed and replaced in 1935–39. Primary floors are wood, some of which are covered with asphalt tile. The entrance vestibule has a quarry tile and ceramic tile wainscot (circa 1935–39). The bathrooms have ceramic tile floor and wainscot (circa 1935–39). The attic is finished with plastered walls and wood floors. The basement is subdivided into five rooms and a central hall. Major walls are masonry and there are plastered ceilings throughout.

- Coursed ashlar foundations
- Red brick veneer walls
- Paneled wood front doors
- Regular fenestration pattern with brick jack-arched or round-arched openings
- Stone sills
- Muntin configuration (largely two-over-two, with other configurations on attic story)
- Denticulated wood cornice
- Gable roof with cross gables and dormers
- Brick chimneys
